AVIATION INVESTIGATION REPORT

A01P0127

LOSS OF SEPARATION

NAV CANADA AREA CONTROL CENTRE
VANCOUVER TERMINAL—ARRIVAL LOW
VANCOUVER INTERNATIONAL AIRPORT,
BRITISH COLUMBIA

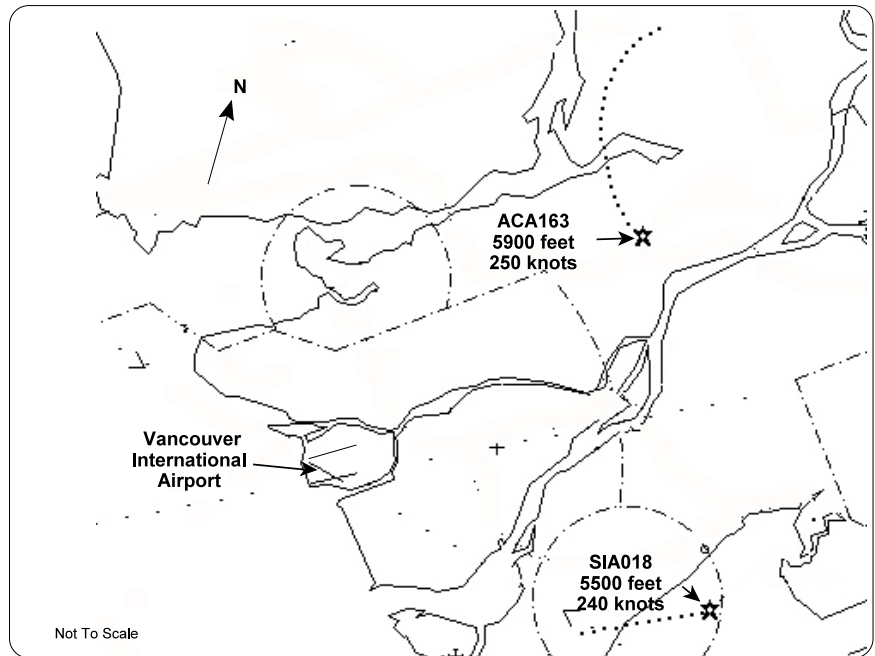
SIA018 checked in with the arrival low controller about 20 seconds later, when their aircraft was in a descent and approaching 5000 feet. The controller acknowledged the check-in and cleared the aircraft to continue its descent to maintain 4000 feet on a heading of 070°. The relative positions of the two aircraft after this initial contact with the arrival low controller are shown in Figure 1.

Figure 1. Relative positions after initial contact with the arrival low controller. The stars show each aircraft's position. The dotted lines show each aircraft's respective previous track.

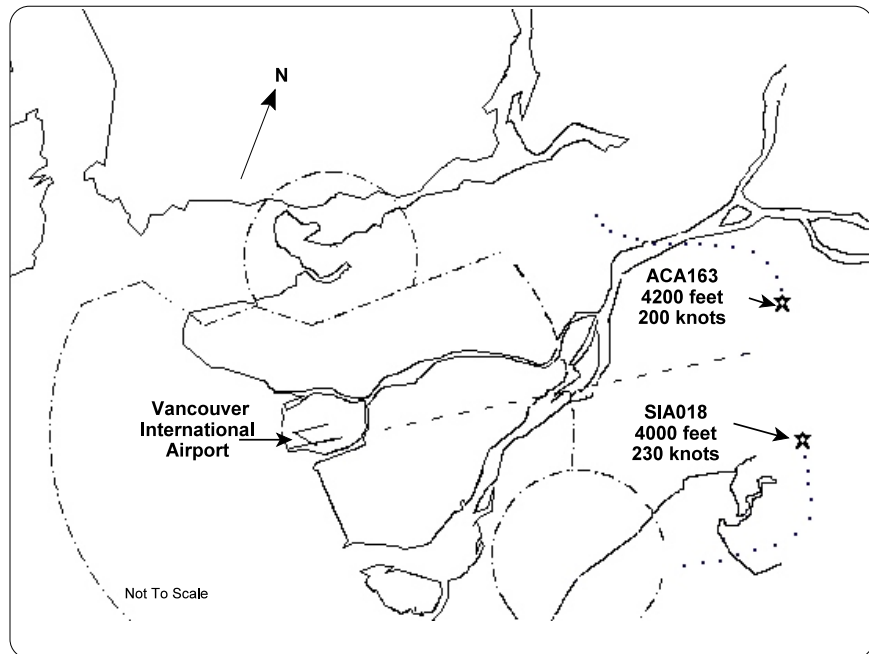
The two aircraft closed to about 3.3 nm and were still converging at a rate of about 8 nm per minute when the controller directed SIA018 to turn to a heading of 290° at 4000 feet. (See Figure 2.) He then directed ACA163 to expedite its descent down to 3000 feet for traffic. On receipt of the direction to “expedite” descent, ACA163’s rate of descent increased to about 1000 fpm, the turn radius tightened, and the speed remained at 170 knots.

Figure 2. Relative position of both aircraft during the early stages of ACA163’s turn to final.

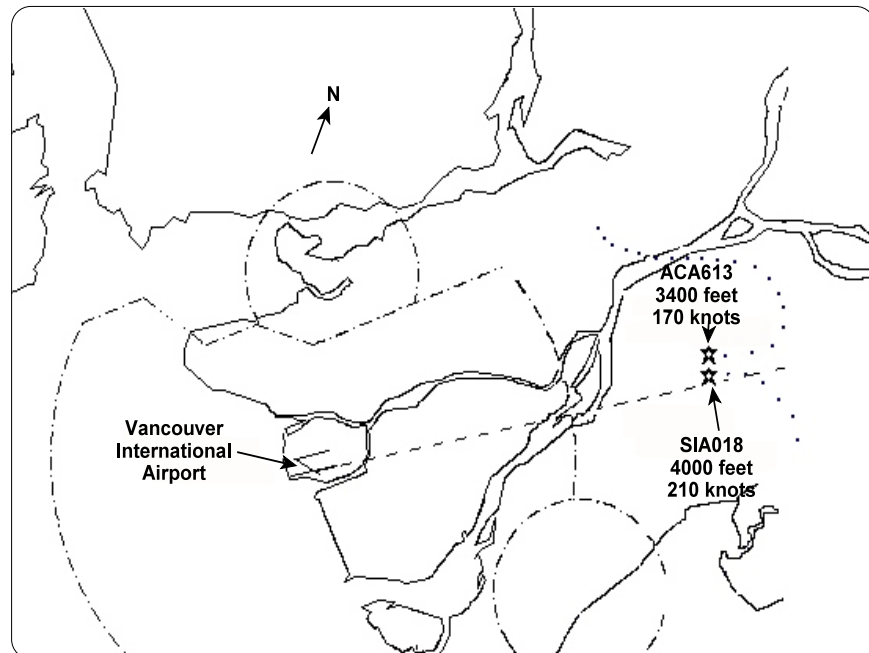
A loss of separation occurred when the two aircraft closed to within 1½ nm and 600 feet in an area where 3 nm horizontal or 1000 feet vertical separation was required. Separation was re-established when ACA163 reached the cleared altitude of 3000 feet.

Figure 3. Loss of separation.
